# Manhole Inspection Summary

Manhole # S21A\_\_041MH

**Location** Address: **601 MONROE ST**

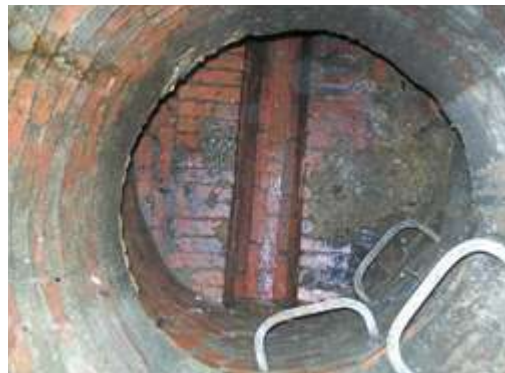
Top View

CANNOT SEE JUNCTION DUE TO CHANNEL OFFSET CONDITION

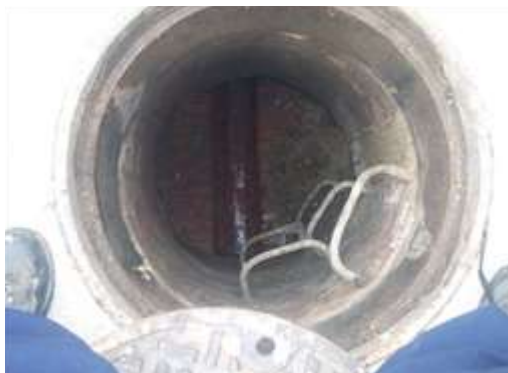
Top View

CHANNEL OFFSET

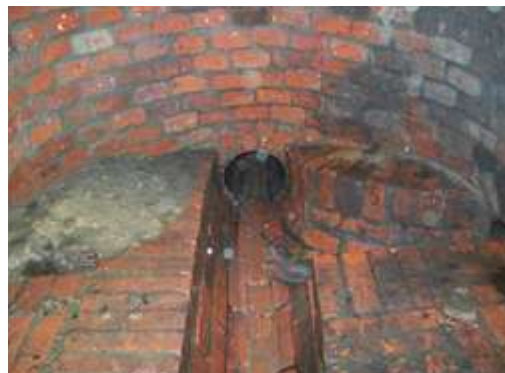
Channel Exposure: **Fully Open** Junc Dist: **2.5** nearest .5 ft. Azimuth: **180**

CHANNEL IS OFFSET 2.5'

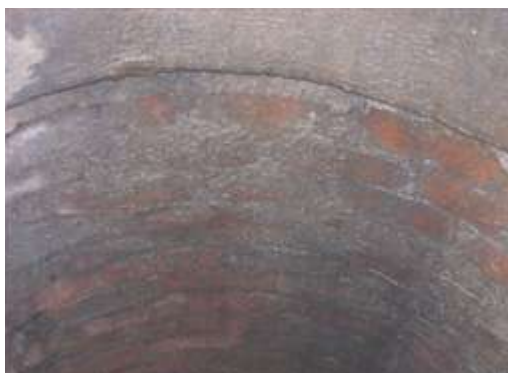
Defect 2

Infiltration: ☐ None ☒ **Joint** ☐ Cracks ☐ Mortar ☐ Roots ☐ Wall

JOINT INFILTRATION

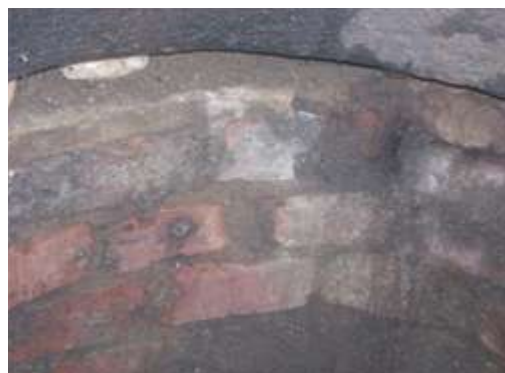
Defect 1

Condition: ☐ Sound ☐ Cracked ☐ Root Intrusion ☐ Loose Brick ☒ **Deteriorated**

DETERIORATED CHIMNEY

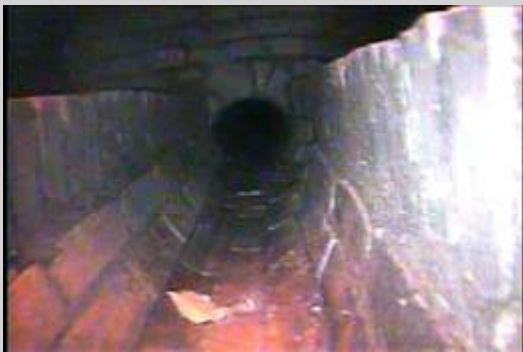
12 O'Clock Outflow

JOINT INFILTRATION
